# Bathroom Leaking Downstairs? Do You Need to Remove the Tiles?

A leak on the ceiling below a bathroom does not always mean the tiled floor must be removed. Water may come from a supply pipe, waste connection or damaged waterproofing, and it can travel before the mark appears. Identify the source before agreeing to hacking and retiling, so the repair addresses the leak rather than only its visible damage.

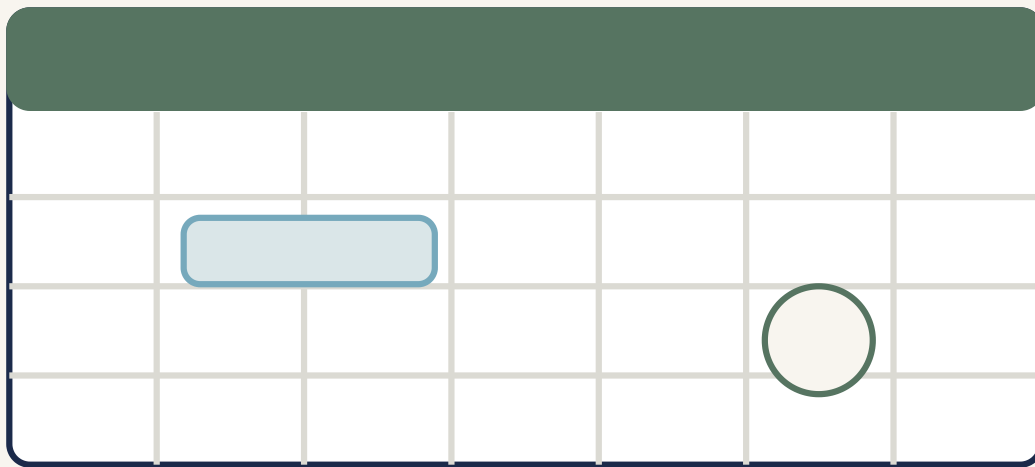
### Record ordinary use and observed timing

### A pattern gives context, not a diagnosis

Record ordinary use and the timing of the mark without treating the pattern as a diagnosis.

Record when you first noticed the mark, whether it is growing and whether there is dripping. Add the ordinary events around it: shower use, flushing, basin use, rainfall or nearby air-conditioning operation. These are clues to give the investigator, not a request to repeatedly run water and reproduce the leak yourself.

Photograph the same area from a similar position and keep a wider image that locates it in the room. Note the date and the conditions beside the photographs. A close-up with no reference to the bathroom above is less helpful than a simple plan showing both the stain and the fixtures it may relate to.

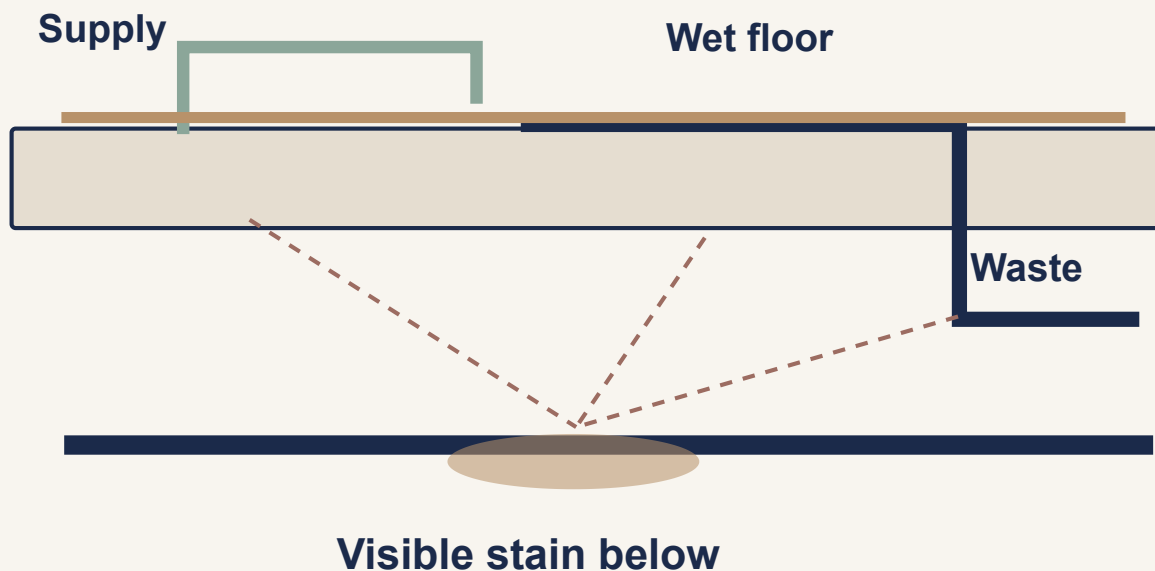
### Trace the source above the stain

Different possible routes. The stain alone does not select one.

The visible mark is an investigation starting point. Dashed routes are possibilities; the drawing does not diagnose the fault.

The water-supply and sanitary systems have different jobs: one delivers water to fixtures and the other carries used water away. A professional investigation may need to distinguish them before deciding whether access is needed to a pipe, a waste connection or the waterproofing beneath the tiles.

The floor's waterproof layer is another possible source of the problem, separate from the plumbing. A liquid wet-area membrane, for example, has preparation, application and protection requirements separate from the visible tile finish. The investigation should establish what system exists and where it has failed instead of assuming that every water complaint requires the same coating treatment.

Also tell the investigator about an adjoining external wall, balcony, roof junction or air-conditioning route. Water may be noticed near the bathroom without originating from its shower floor. A drawing of the surrounding spaces helps keep the diagnosis open until the evidence narrows it.

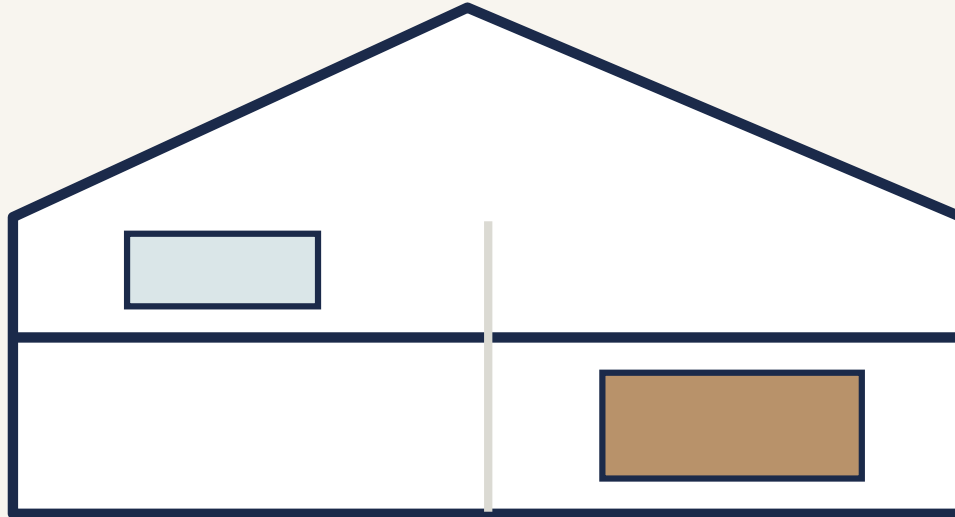
Repair above, making good below

Define both affected areas

Define the repair above and the finishes disturbed in the room below.

A local connection defect may support a local repair if the surrounding work remains serviceable and the access is practical. A wider wet-area problem may require a larger reinstatement scope. The important distinction is why the proposed boundary addresses the identified route and how the repaired area joins the work being retained.

Ask what finishes will be disturbed on both sides: the bathroom above and the room below. If a local opening is proposed, establish what can be retained, what matching materials are available and what visual difference may remain. If the whole bathroom is to be rebuilt, ask which parts of that decision address the leak and which are elective improvements.

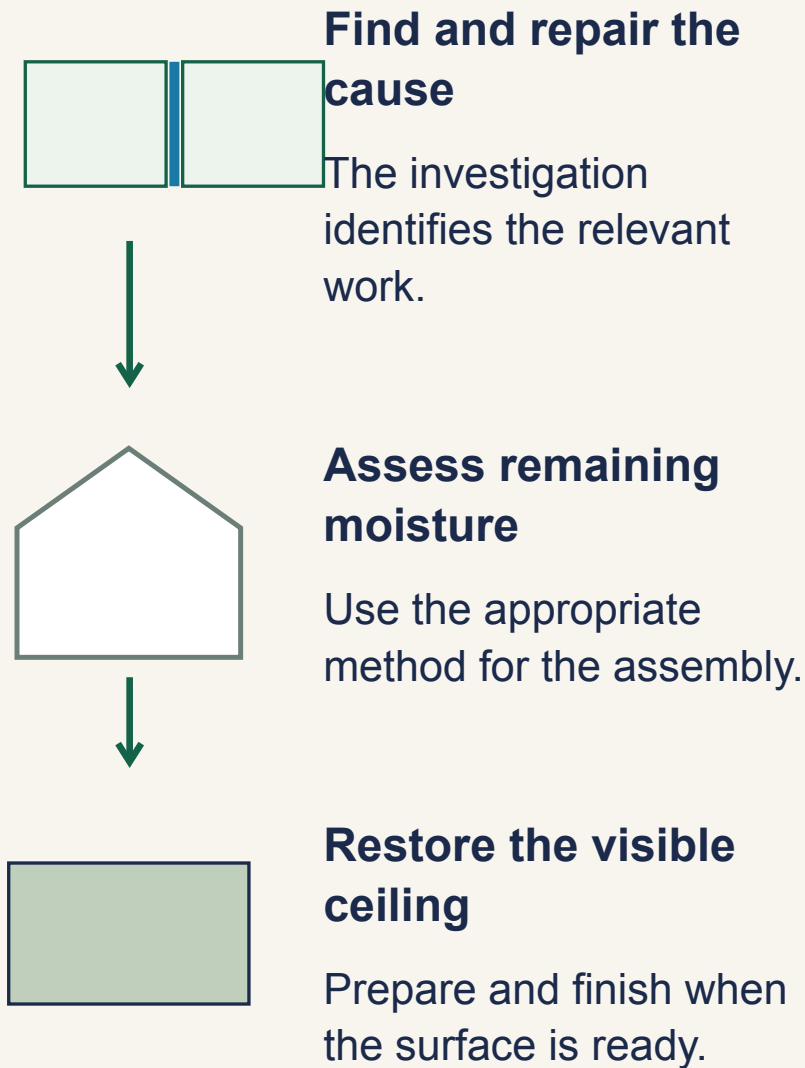
### The ceiling finish comes after the cause

Find and repair the cause: The investigation identifies the relevant work. Assess remaining moisture: Use the appropriate method for the assembly. Restore the visible ceiling: Prepare and finish when the surface is ready. Schematic only; no dimensions or site-specific approval are implied.

The repair plan should include how the result will be checked and when affected finishes can be reinstated. Agree the relevant test or observation period with the responsible specialist, including any limitations. Ask what drying or curing conditions need to be met before making good, and how the team will check them on site.

The [moisture source must be addressed before making good a damp or mould-affected area](#). Ask the team to assess affected material and drying needs instead of immediately hiding the mark with paint. Record the repair and subsequent observations so a later recurrence can be compared with what was actually done.
